BAY SPRINGS MILL: HISTORICAL ARCHAEOLOGY OF A RURAL
MISSISSIPPI COTTON MI. (U) RESOURCE ANALYSTS INC
BLOOMINGTON IN W H ADAMS ET AL. 30 JUN 81 RAI-1427
C-07009(79)

Historical Archaeology of a Rural Mississippi Cotton Milling Community

RAI-1427

June 1, 1981

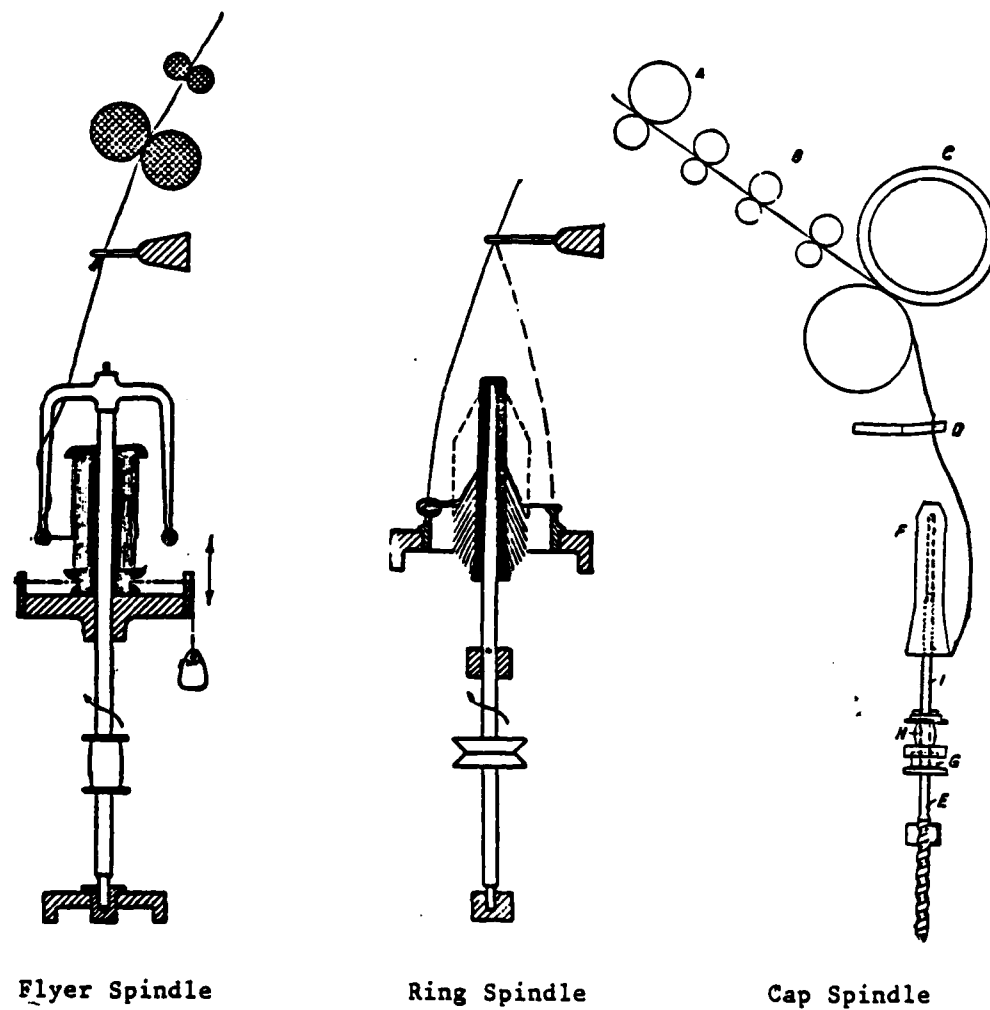
Figure 9.2.--Flyer Spindle, Ring Spindle, and Cap Spindle. (From Kissel 1918).

The answer to this problem came in the form of two inventions: Charles Danforth's cap frame and John Thorp's ring frame both invented around 1828 (Lozier 1978:210). Charles Danforth was the brother of George Danforth. His cap frame consisted of supporting a metal cap on a dead spindle (Figure 9.2). The bobbin was driven by a whorl placed over the spindle and spun freely about it. "The thread coming from the rollers above the cup was fed outside the cap, thence against the underside of the cap or ring before being wound on the spindle" (Lozier 1978:213). When the bobbin was rotated at high speeds, the yarn created a balloon around the cap. Air resistance produced a drag which, in conjunction with friction of the yarn on the bottom of the cap, wound the yarn on the bobbin and twisted it. The Danforth cap could run up to 8,000 rpms (Catling 1978:183).

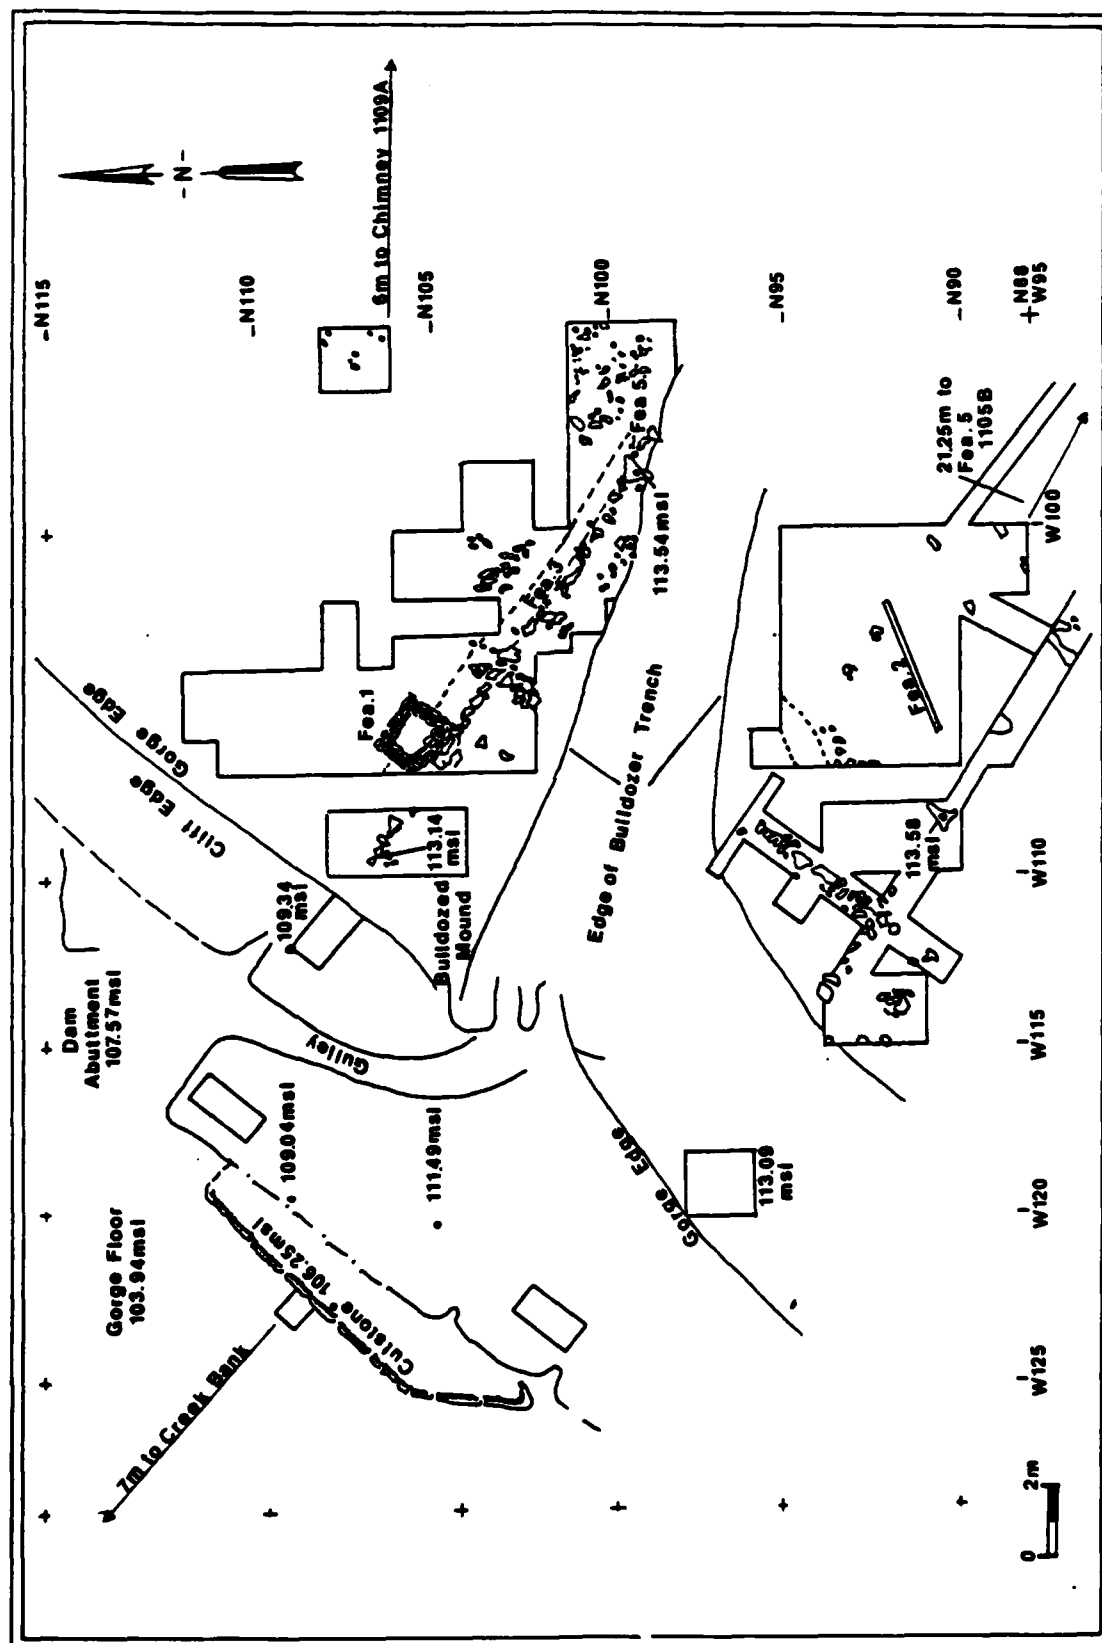
Figure 10.1.--Excavation at Structures D and E, The Mill.

Recommendations from the testing phase called for extensive hand excavations after clearing and removal of overburden by heavy equipment. A total of 19 2x2 m units to a depth of 20 cm and 20 2x2 m units to 60 cm were recommended, or a total of 156 m² and 63.2 m³. Because of two hurricanes cutting into a restricted time schedule our level of effort was reduced. Twenty 2x2 m units, 31 1x2 m units, and two 1x1 m units were excavated. Also, in following out the wall line of the structure, an additional 21.5 m² were exposed. A total of 48.76 m³ was excavated at the mill, less volume than we had planned, but the increased areal exposure (163.5 m²) provided the needed data. Additionally, we were able to use bulldozers for deeper stripping than we had originally planned.

On the south side of the building, in Unit 44, was evidence of another small building addition. This is interpreted as a porch or shed addition. This addition may have been added when structure E was built since the large flat stones used to construct this small platform are like those found in structure E used as piers. The addition consists of an additional three large flat stones running 2 m (6 ft) parallel to the south wall. The burn line follows these stones (Figures 10.1, 10.9).

This burn stratum was not contiguous across the site but was concentrated in distinct areas, perhaps hot spots (Figure 10.1). To the east, the burn level rises in elevation and disappears along a northeast to southwest line from N88.50/W99.5 to N86/W102.5 (see Trench C and A, Figure 10.1) indicating the eastern edge of the building.

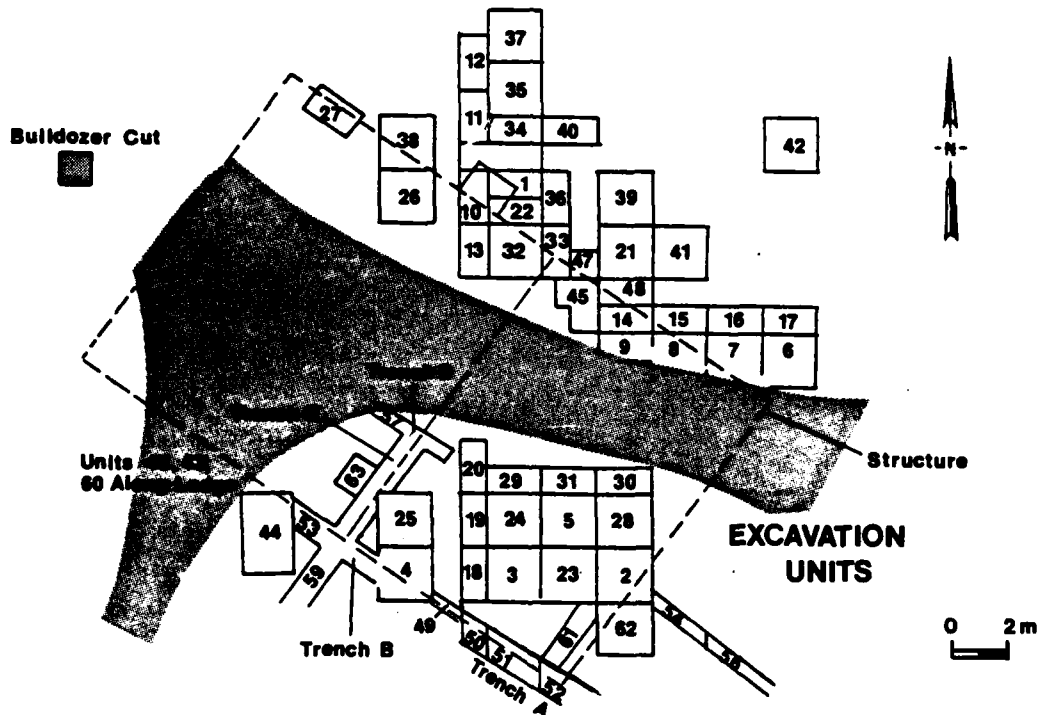
Figure 10.3.—Excavation Units at the Mill.

Stratigraphy at this site was complex, as a result of the burning of the mill, scavenging, earlier bulldozing, fill activities, and runoff from the spoil pile south of the site. For purposes of discussion we divided the mill area into two sections separated by the vandal east/west bulldozer trench. The southern portion of the mill was characterized by up to .5 m of overburden, half of which we removed by careful backblading with a rubber-tired bulldozer before hand excavation. The northern section included the north stone wall and chimney and was much more complex. Near the cliff in excavation Units 26, 38, 13, 10, 32 and 33 (Figure 10.3), a considerable amount of this overburden had been piled up by the north/south bulldozer run. Underneath this was much brick chimney rubble and charcoal. To the north of this area, the bedrock was only 15 cm below the surface. The northeastern part of the mill contained much less disturbed soils than the southern part.

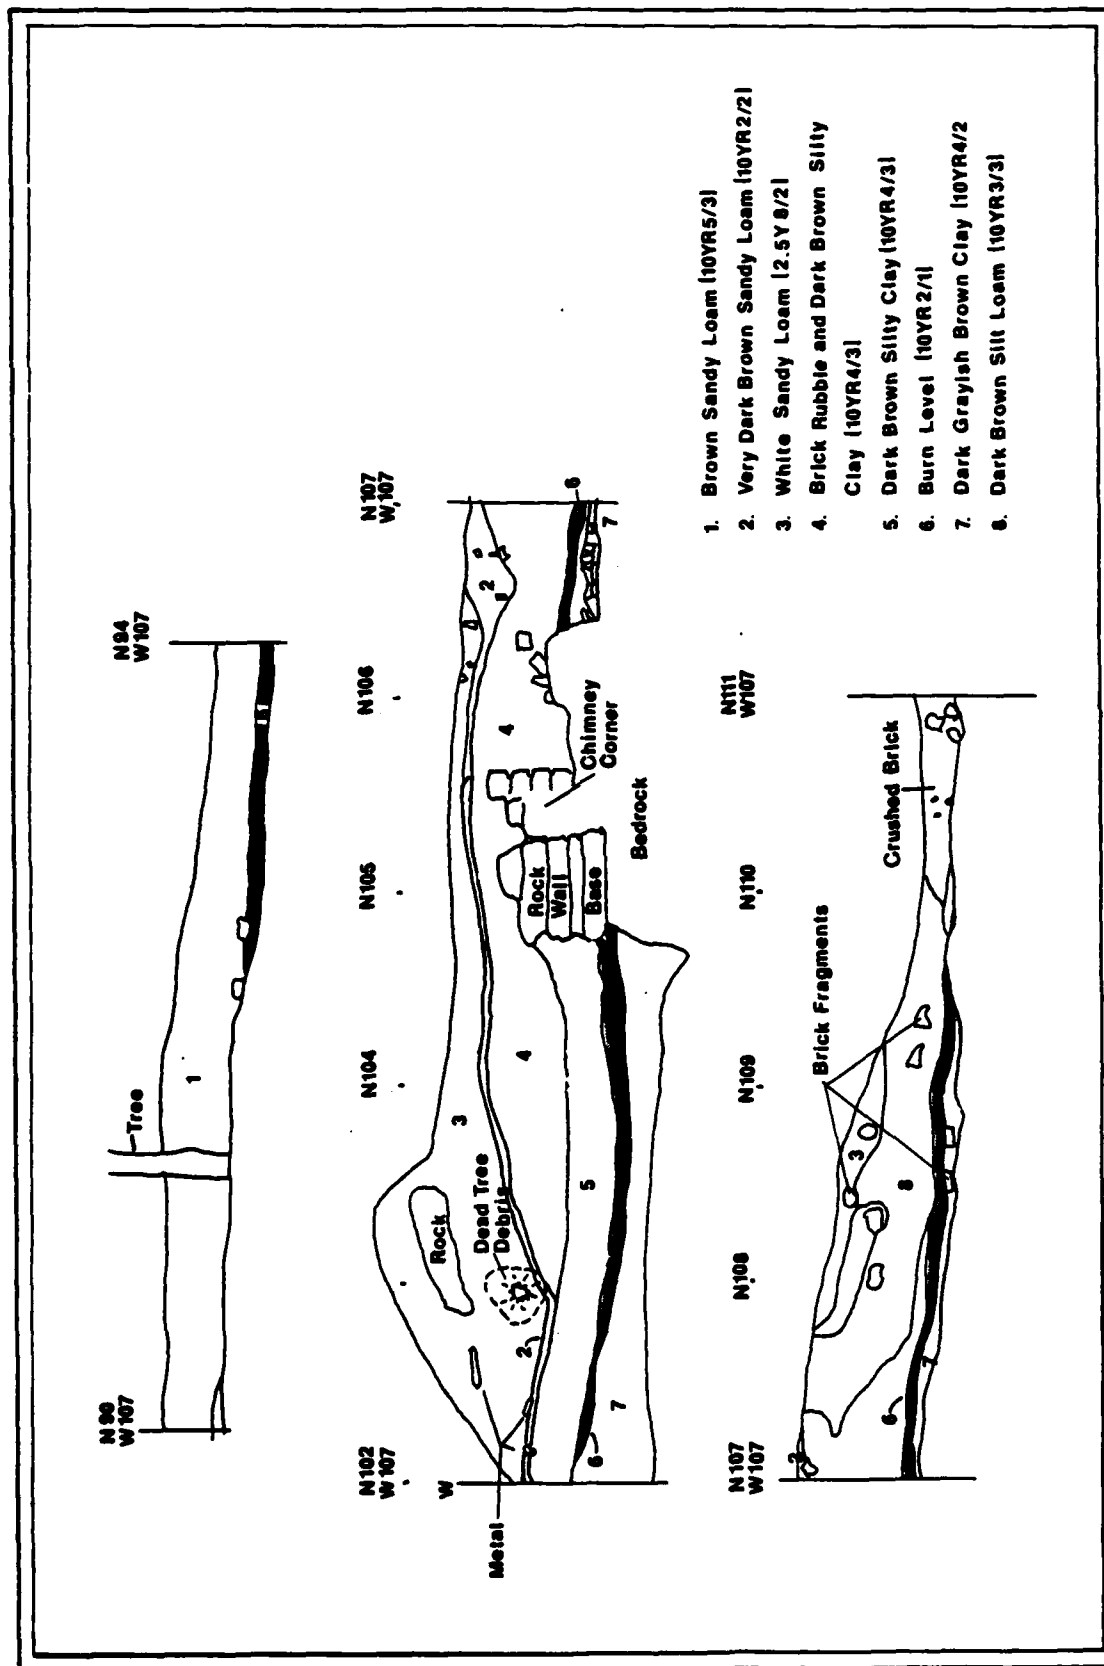
Figure 10.4.--Stratigraphy, 22TS1103, The Mill.

Figure 10.4 details the stratigraphy seen along the W107 line from N90 to N111. The southern section of the mill was characterized by a brown sandy loam (10YR5/3) which continued to the burn stratum, a charcoal layer up to 6 cm thick. Below this the soil revealed evidence of the intensity of the fire. The soils had been fired to a brick red. Toward the bulldozer cut soils changed to a mottled gray and brown silty clay (10YR5/1) and (7.5YR5/6). This area is the result of wheeled vehicle action and is noted as Feature 4D.

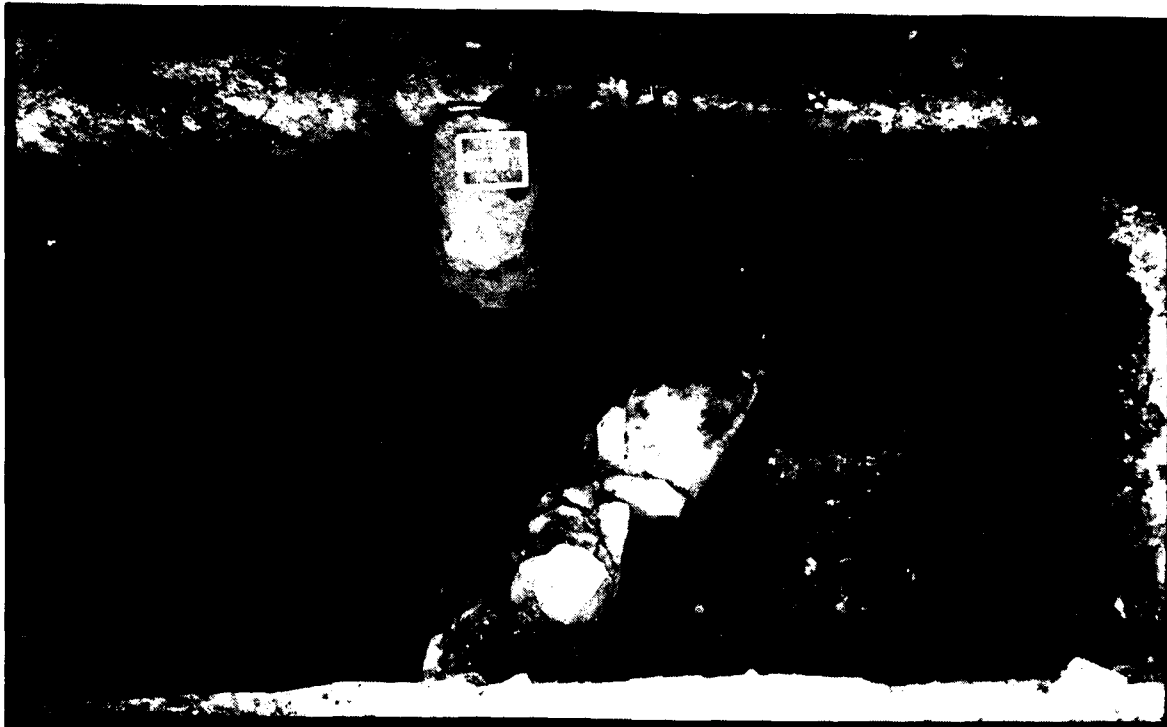
Figure 10.11.--Structure D and E, Both Showing the Dripline.

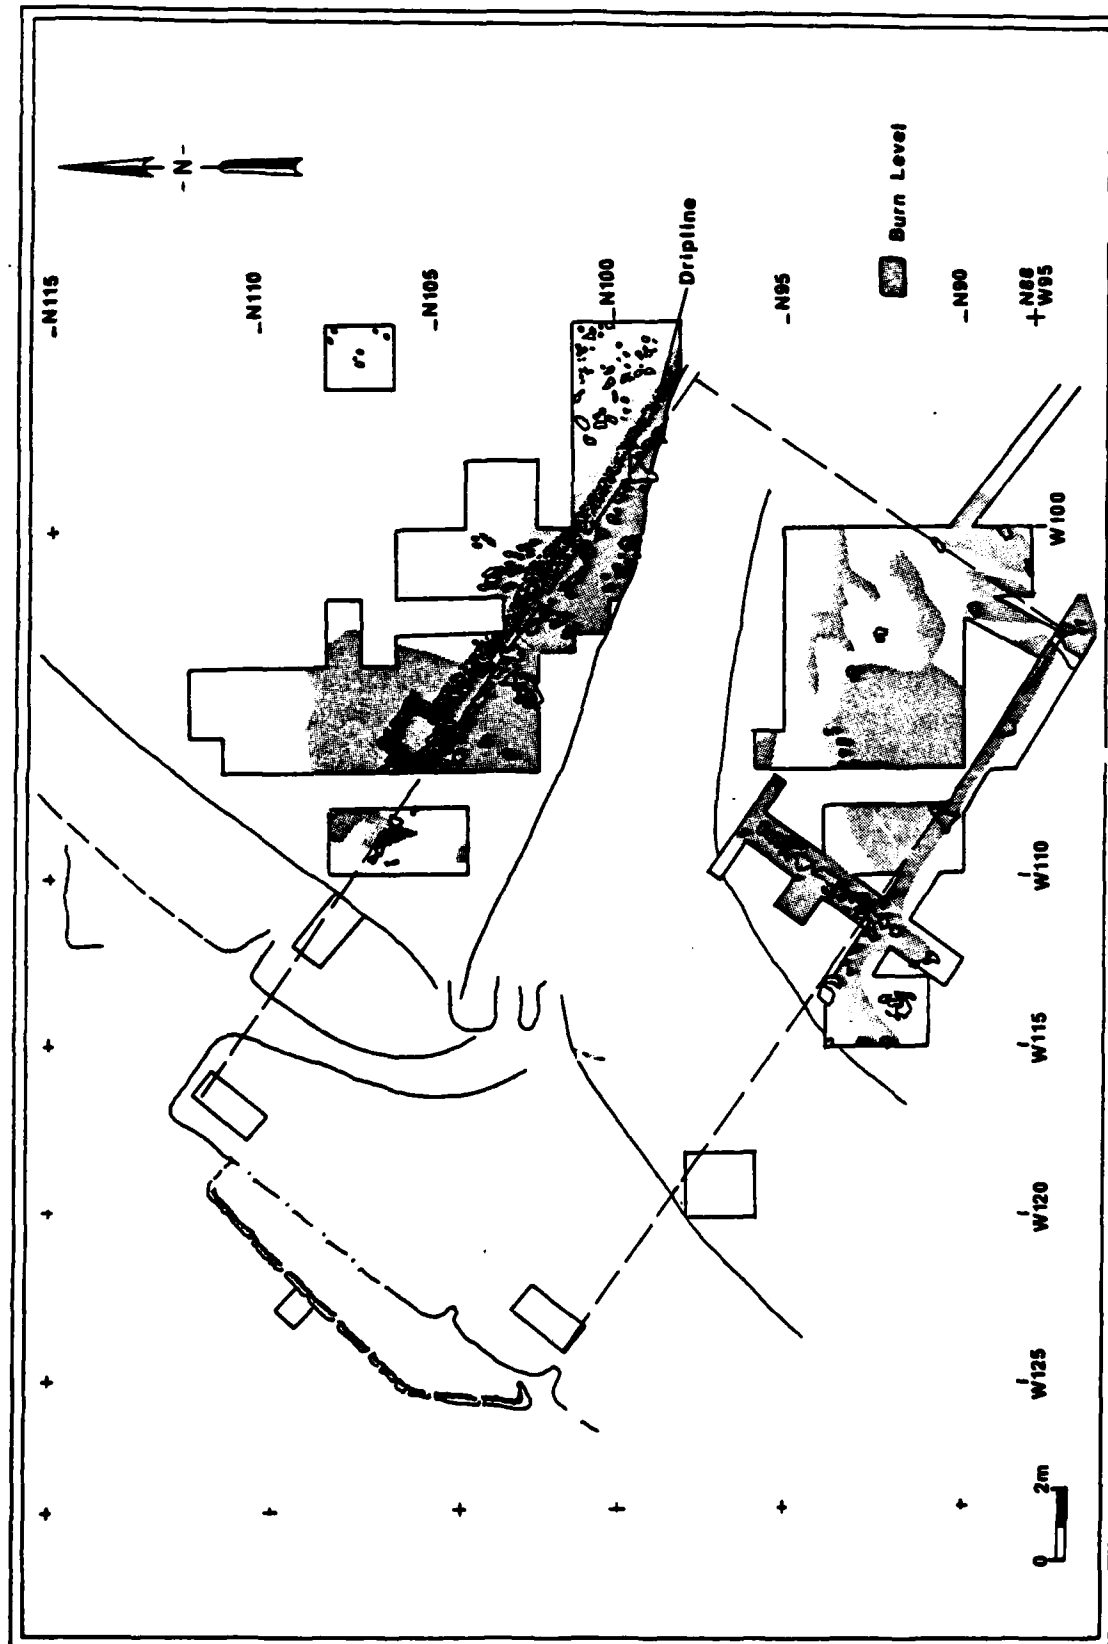
Figure 10.12.--Areal Extent of Burn Level, and Dripline.

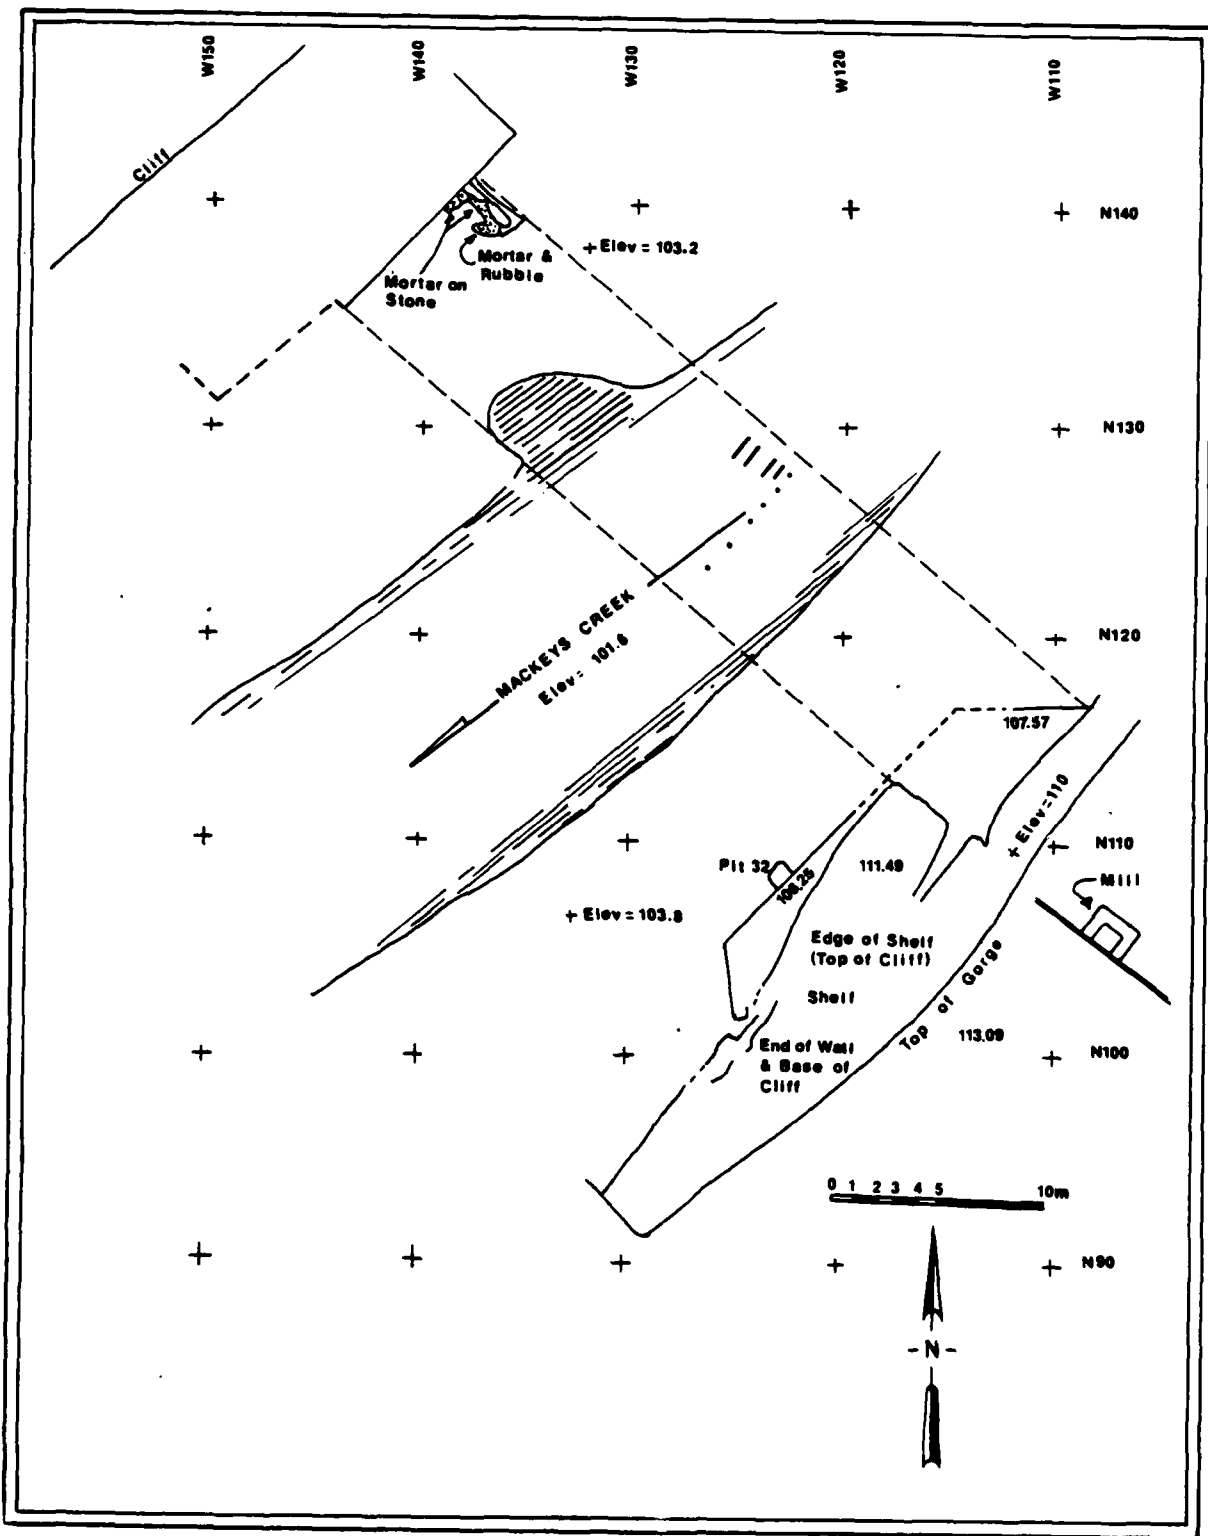
As the first task, Gresham built two stone abutments. These abutments were dry laid blocks of stone, well-dressed, and tightly fitted (Figure

Figure 10.13.--Probable Alignment of the Bay Springs Mill Dam.

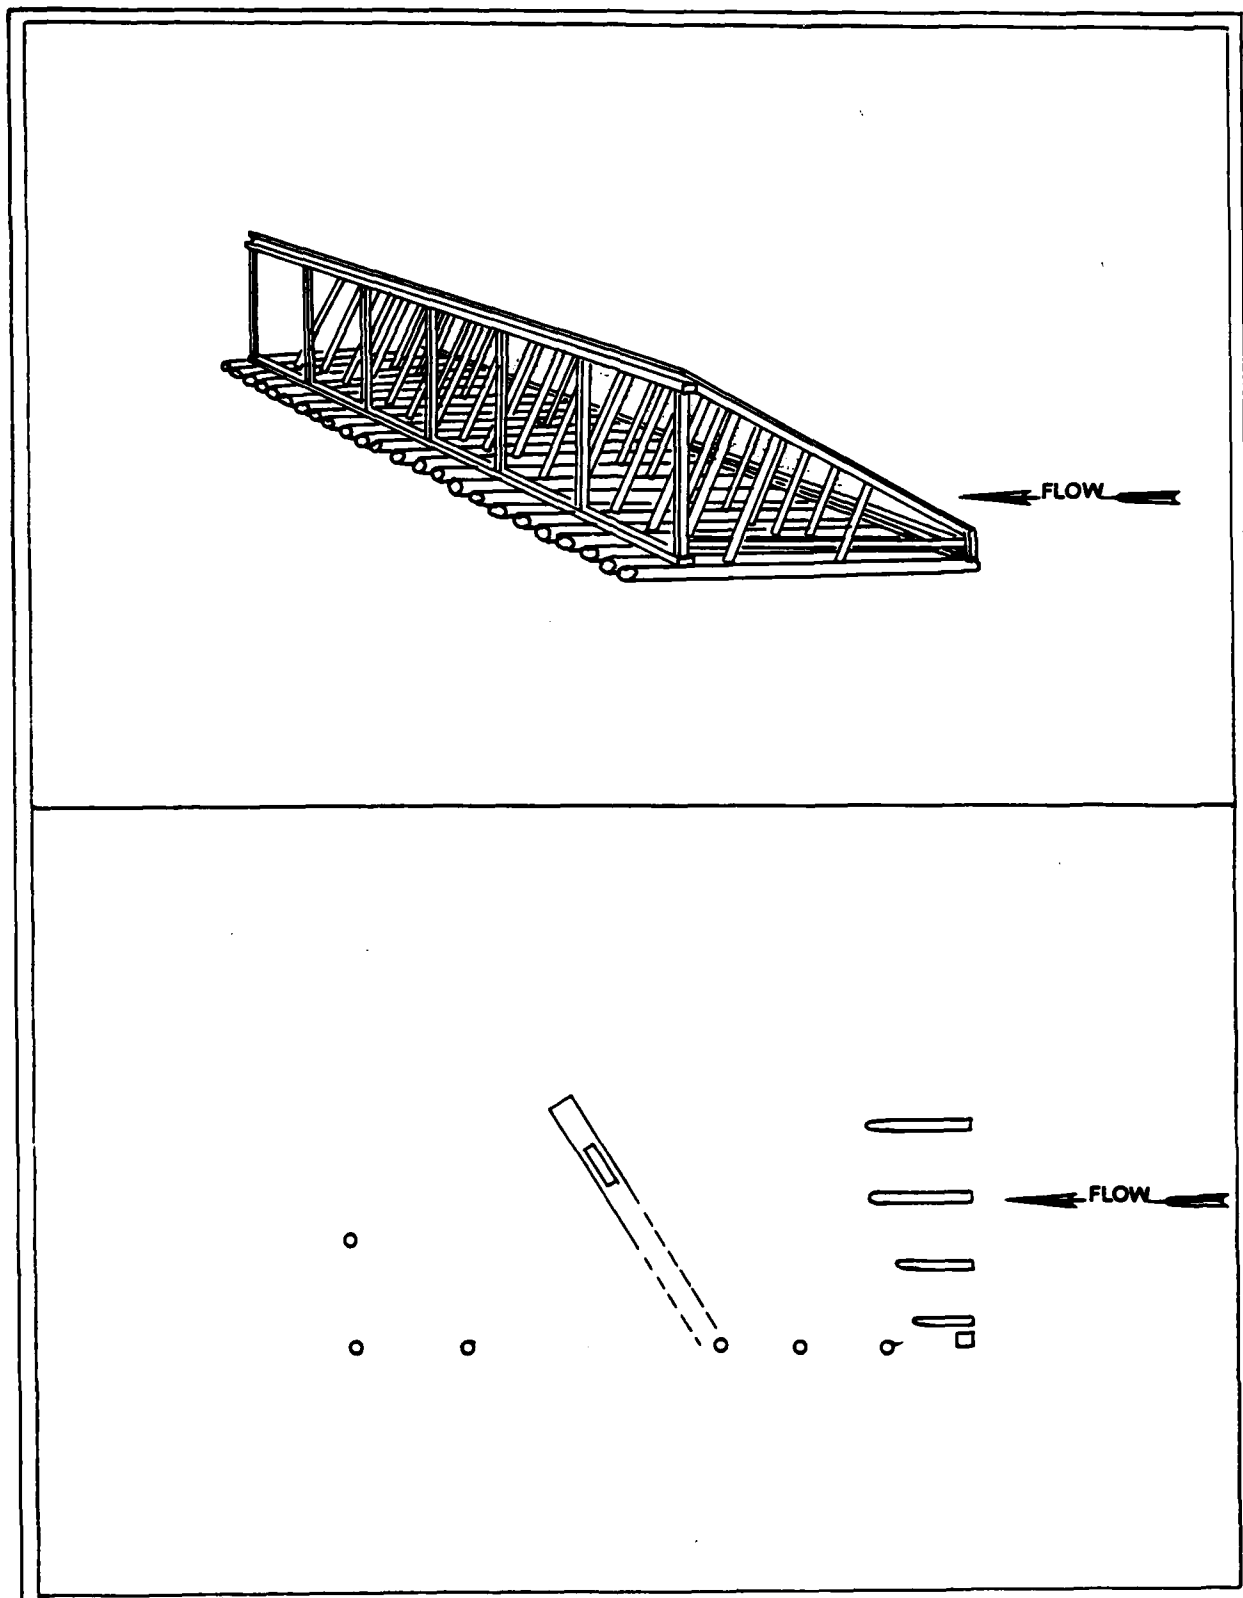
The dam at Bay Springs was quite similar, based upon a 1890s photograph of its remains, (Figure 10.5) and parts of the wooden structure surviving today. Figure 10.15 shows a wooden frame dam redrawn from Leffel's study, and the wooden remains we found in Mackeys Creek. Seven upright posts were located, besides a line of sloping posts and one heavy timber. The dam was 34 m (112 ft) long, 3 m (11 ft) high, and about 9 m (30 ft) wide at the base.

Figure 10.15.--Typical Wooden Frame Dam and Remains of the Bay Springs Dam.

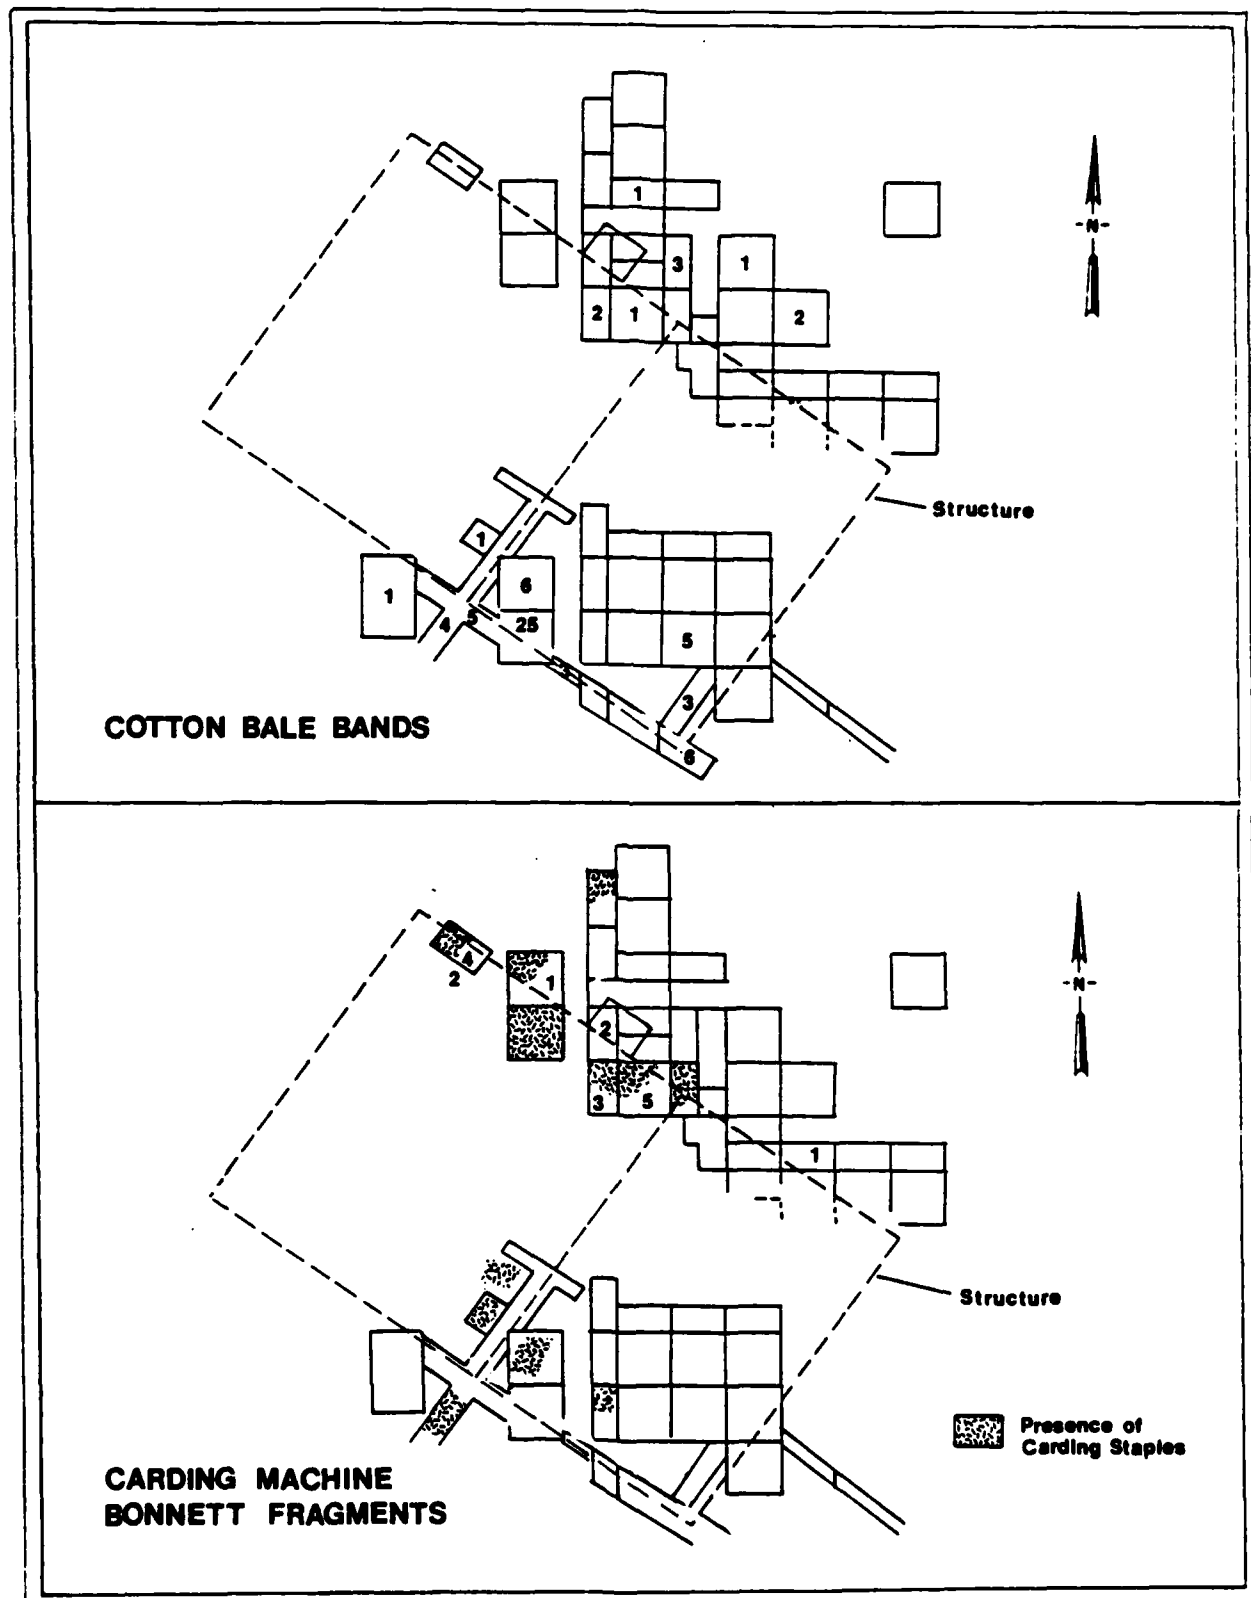
Figure 10.20.--Distribution of Cotton Bale Bands and Carding Machine Bonnett Fragments.

At the Bay Springs Mill, this process took place in the southern side of the mill. Evidence for this activity comes from the clustering of cotton bale bands in this area (Figure 10.20). No artifacts could be

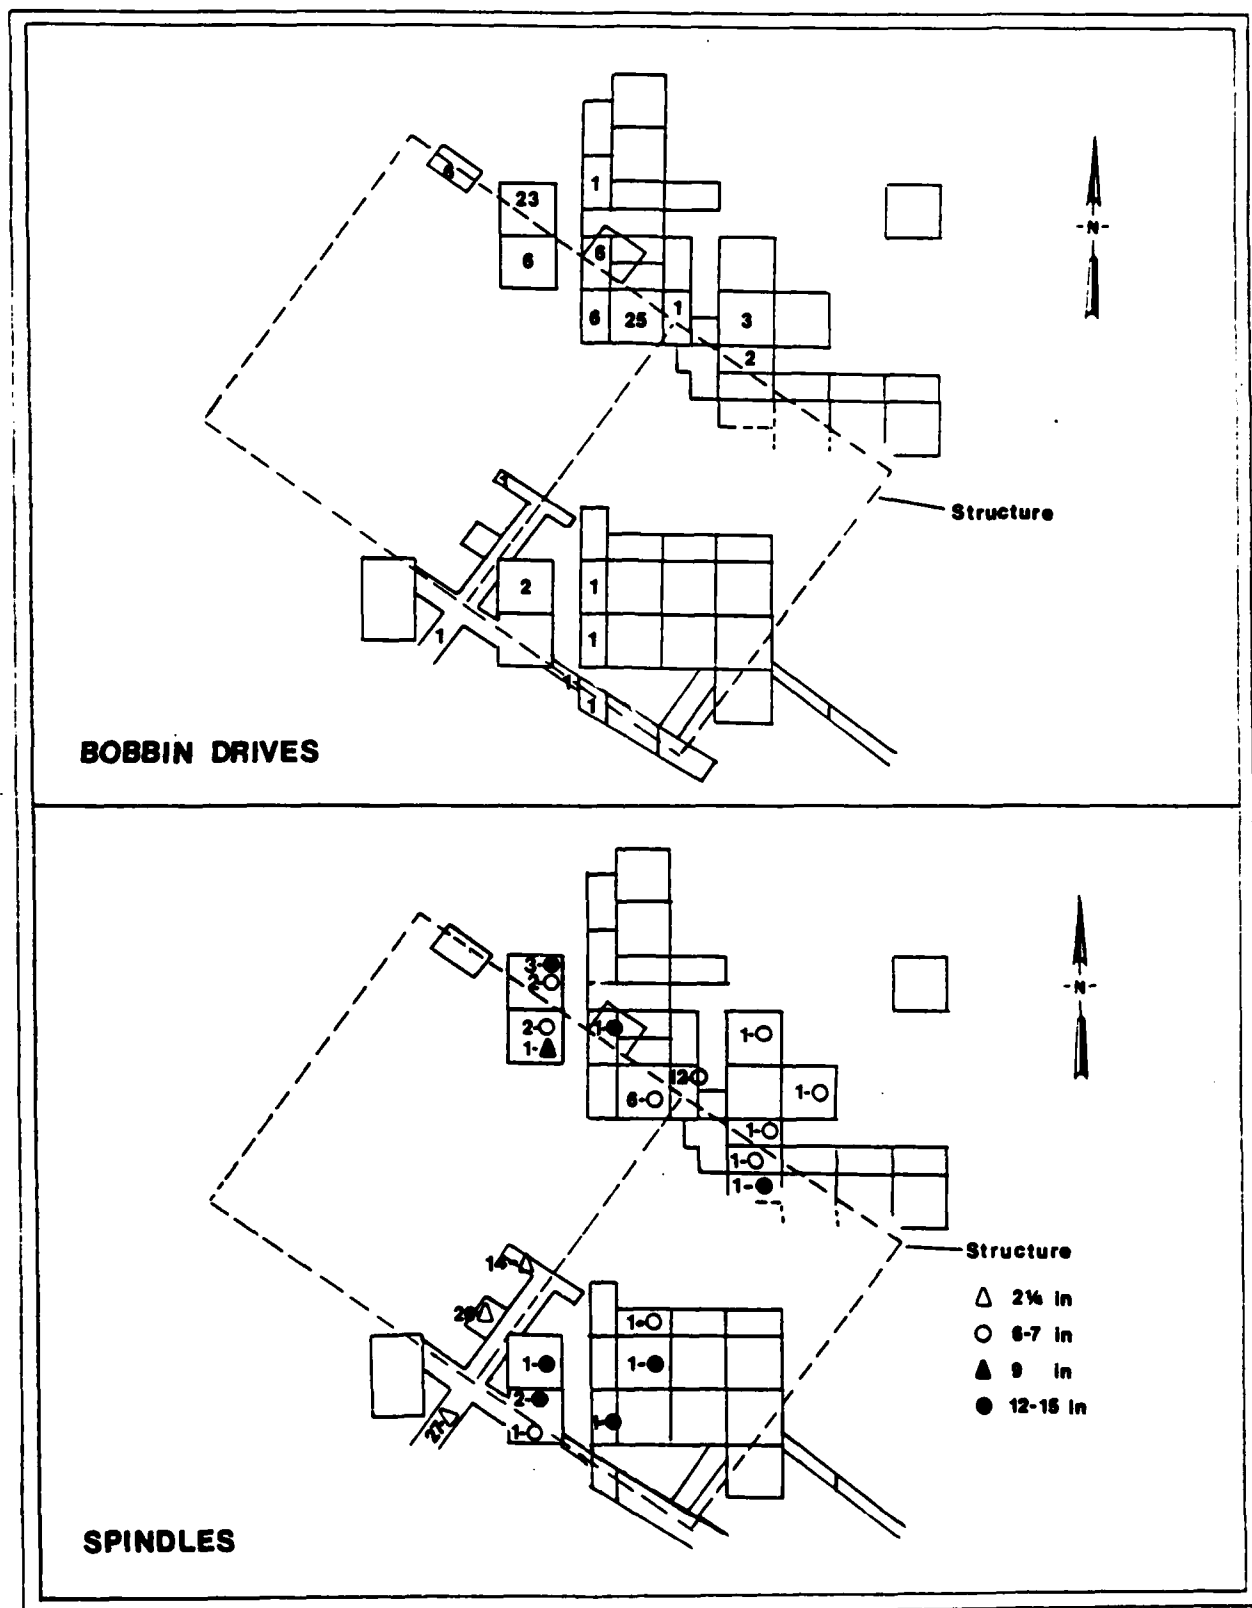
Figure 10.22.--Distribution of Bobbin Drives and Spindles at the Mill.

Figure 10.22 shows the distribution of spindles by length. There is a definite pattern of distribution. The longest spindles are in the north and a small spindle clusters in the southwest area. This distribution could show a distinction between slubbing frames on the south and roving and spinning frames on the north.

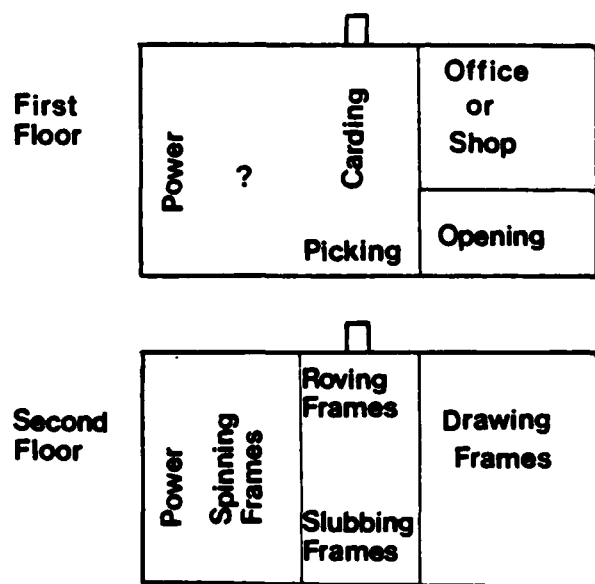
The above is a possible reconstruction of the exterior and interior of the Bay Springs Union Factory. Because of the extensive damage to the mill prior to our excavations, we can only make the most tentative statements concerning its exterior appearance or the distribution of the mill machinery within the mill. Our reconstruction is enhanced by historic analogy. Yet we will not truly know what the mill looked like until a photograph of it is found. Hopefully our rendition will bear some similarity.

Figure 10.23--Possible Spatial Organization of Bay Springs Mill.

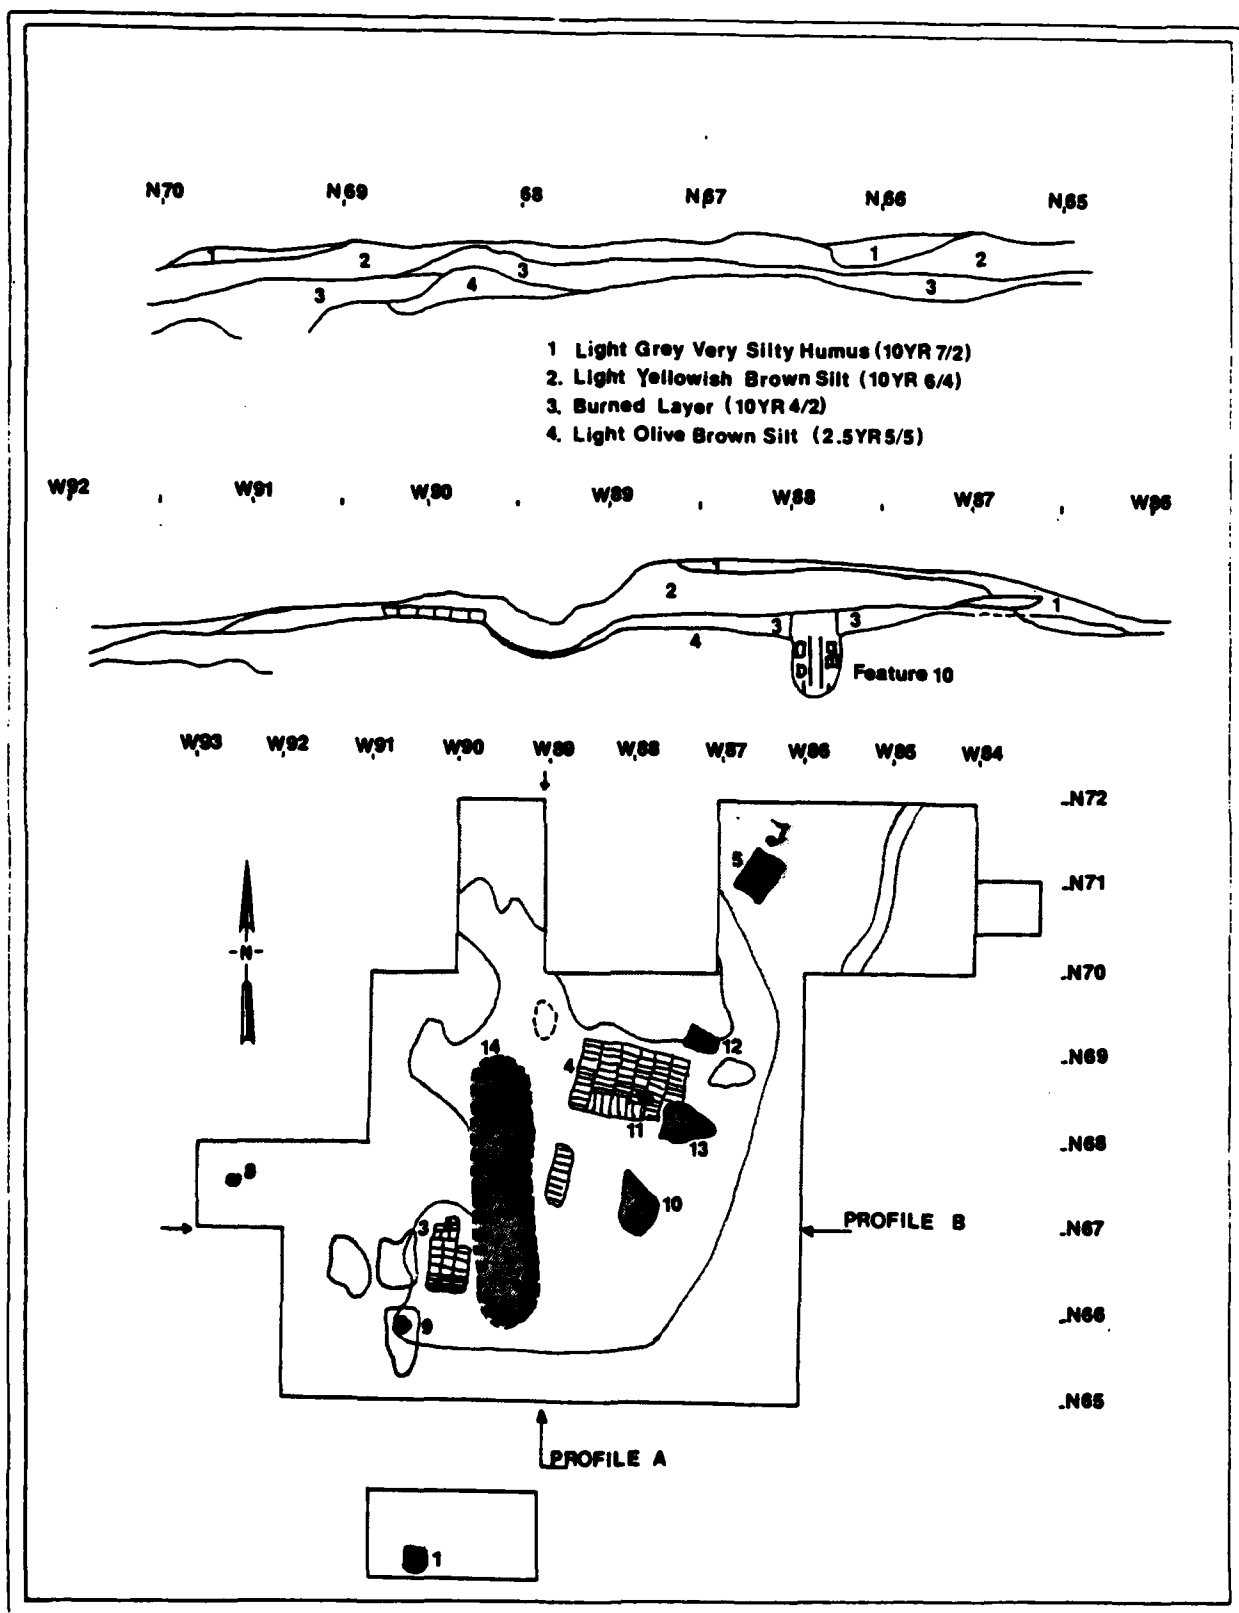
Figure 10.24.--Plan View and Stratigraphy at Site 22TS1103B.

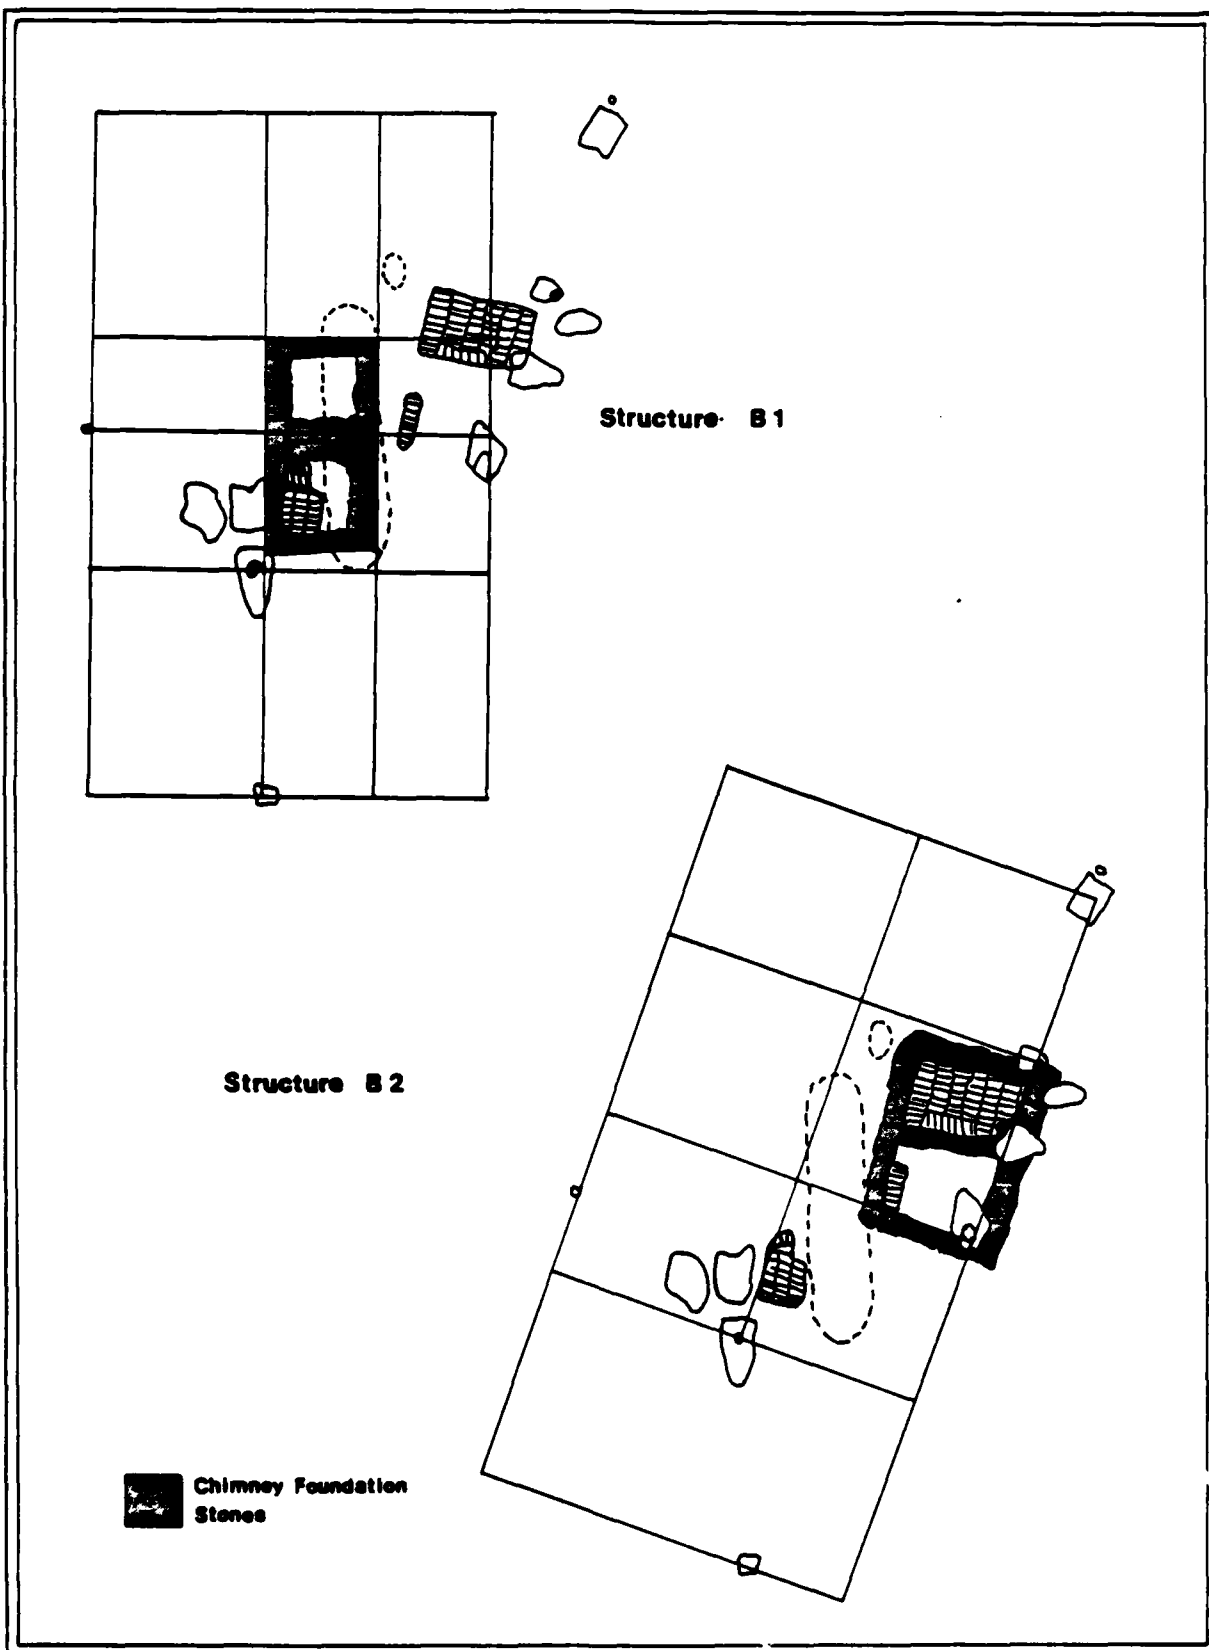
Figure 10.25.--Two Hypothetical Reconstructions at Site TS1103B.

A list of features and their descriptions is presented in Table 10.1. The 14 features encountered at this site consist of seven brick-lined post holes, three shallow post holes, two filled trenches, and two brick floors. The structures at this site present many problems in terms of architecture. First the structure had little domestic trash and does not appear to have been a domicile. Hence, comparison with folk housing architecture is limited. Second, the architectural evidence is contradictory. There may have been two structures on the site. While the post holes share certain matrix attributes like charcoal and brick-lining, the alignments projected from their locations conflict with the alignments of the brick platforms. Two possible functions for these brick platforms exist. They may be either two or three brick pads for supporting heavy equipment like a cotton gin or scales. However, no iron rods remained to anchor any equipment. The second idea is that these are the remains of double chimneys (Figure 10.25).
